The Incident of the Bjork-Shiley Heart Valve

BME 462 Biomedical Instrumentation – Lecture Notes, by Ying Sun, 2012

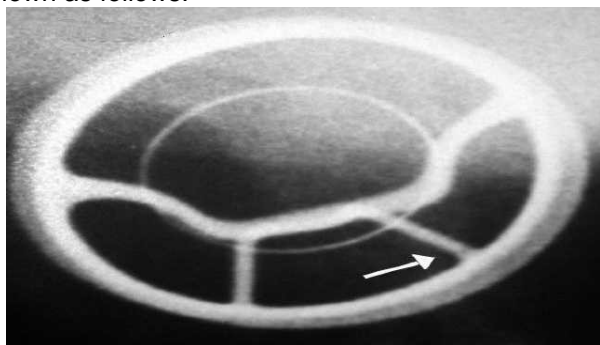
The cause of failure of these valves was determined to be fractures in the outflow strut, known as outlet strut fracture (OSF). One end of the strut would fracture first, followed generally within a few months by a fracture of the other end. Fracture occurred from brief impacts on the outlet strut

connections due to over-rotation of the disc closing with almost ten times the force of the disc opening. This created bending stresses beyond the strut's fatigue endurance limit that eventually caused fatigue-induced fracture after many occurrences of outlet tip overloading. Valve failure caused the disk to become free from the valve, so blood flow could no longer be regulated, leading to cardiac death if it was not detected in time. These fractures occurred during premarket trials and were assumed to be due to the strut welding. However, Shiley assured the FDA that these failures were flukes and that the lower risk of thrombus in the new design was much more significant than what was thought to be a small chance of OSF.

Even though the actual failure mechanism was still unknown, the FDA approved the device, relying on an "Honor System" and trusting the company to report any problems with the valves. As lawsuits began to be filed, Pfizer, the company that bought Shiley in 1979, insisted on secrecy agreements that restricted the release of important information to the FDA and doctors. Therefore, many patients continued to receive faulty valves even after the company was aware of the defects. An X-ray image of a valve with a complete fracture of the base of the outlet strut is shown as follows:
