# Bug Report

BME 363 Biomedical Instrumentation Design Laboratory, University of Rhode Island

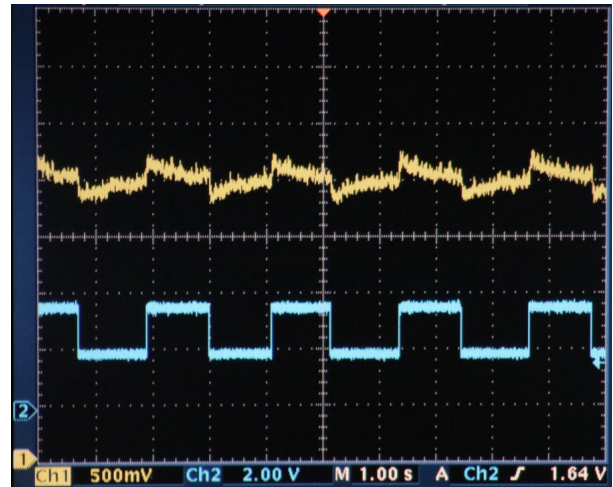
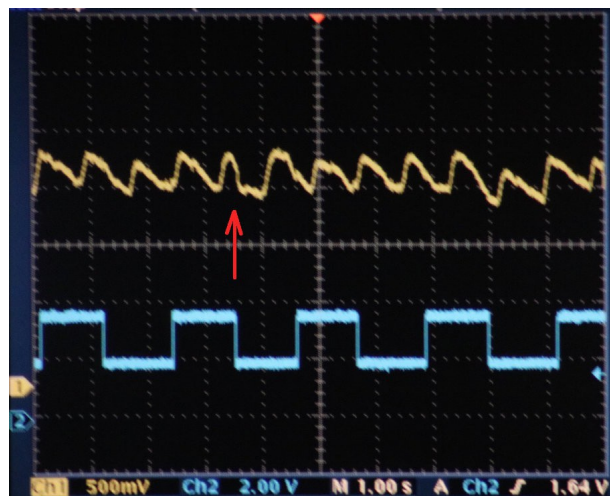
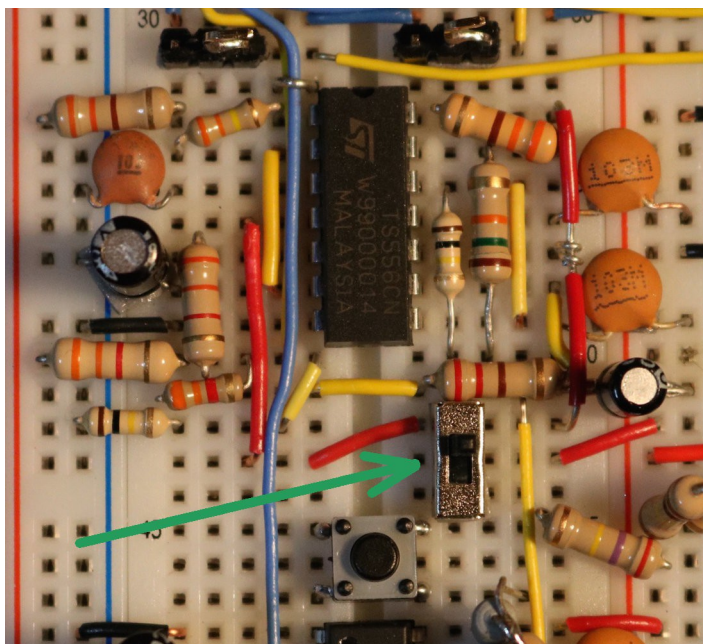
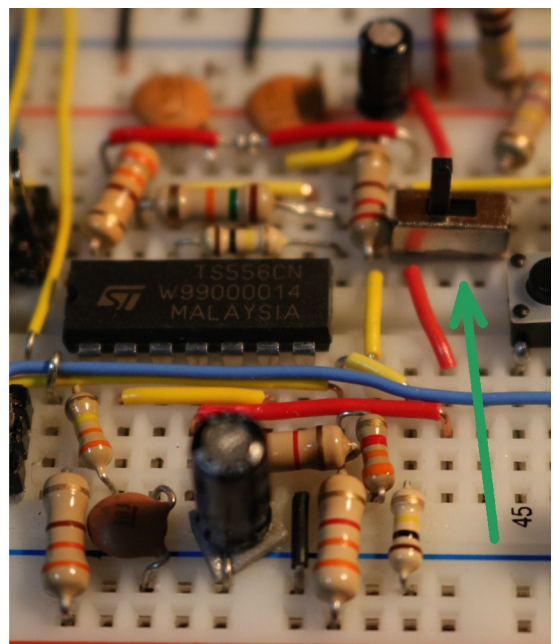
There was an undesirable cross-talk between the PPG circuit and the waveform generation circuit. The fast-switching square wave from the LM556 somehow affected the PPG waveform. In the top figure, channel 1 (yellow) shows the PPG without finger inserted waveform generator output (AN0, pin 2 of PIC). In the next figure, with finger inserted, the PPG waveform was affected at certain points such as the one shown by the red arrow. The problem could be accentuated for a small-magnitude PPG.

The coupling could have come through the power supply. Adding a large capacitor (such as 220  $\mu\text{F}$ ) between the 5V line and the ground line could suppress but not completely eliminate the noise.

The noise went away when the waveform generator circuit (LM 556) was turned off. Thus, a switch was added; the Vcc and the two reset lines were connected to 5V via the switch. When the PPG is in use, the waveform generator can be manually turned off to get rid of the noise problem.
