The Incident of the Bjork-Shiley Heart Valve

BME 462 Biomedical Instrumentation – Lecture Notes, by Ying Sun, 2012

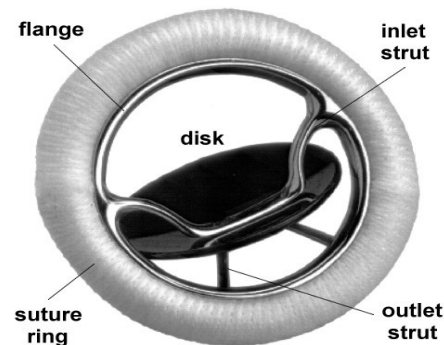
Bjork-Shiley Convexo-Concave Valve

The BSCC valve was used to replace either the aortic or mitral valves. Changes in pressure up and down stream of the valve open and close the disk to regulate blood flow. The struts constrain the range of movement of the disc, allowing the disc to open to an angle of 60 or 70 degrees. The suture ring, made of Teflon, was sewn to the cardiac tissue to hold the valve in place. Though many of the BSCC heart valves fractured during trials, it was determined to be very effective for valve replacement, and was thus approved for market applications.
